# The role of nano-sized intergranular phases on nickel alloy 725 brittle failure

Maria Sofia Hazarabedian<sup>1</sup> and Mariano Iannuzzi<sup>1</sup>✉

*npj Materials Degradation* (2021)5:39; <https://doi.org/10.1038/s41529-021-00185-2>

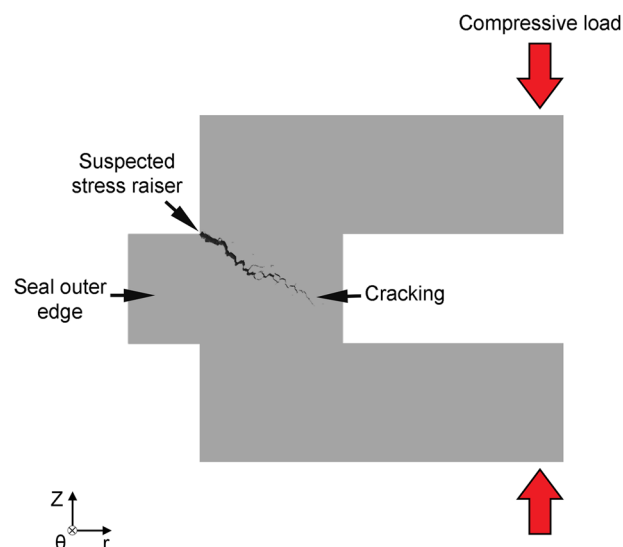
This investigation was conducted on an Alloy 725 seal used in subsea equipment that failed in service and was deemed susceptible to HE in a previous work<sup>6</sup>. Figure 1 illustrates the location of the main crack. Cracking occurred in both the radial and angular (circumferential) directions, initiating at suspected stress raisers and surrounding the component's perimeter. The seal was not directly exposed to cathodic protection, and no evidence of calcareous deposits was found (NB: calcareous deposit formation is an indirect indicator of a net cathodic polarization, which leads to hydrogen charging of subsea equipment<sup>39,40</sup>).

**Fig. 1** Failed component outer area cross-sectional view. Sketch illustrating a plausible stress concentration point and crack propagation direction.

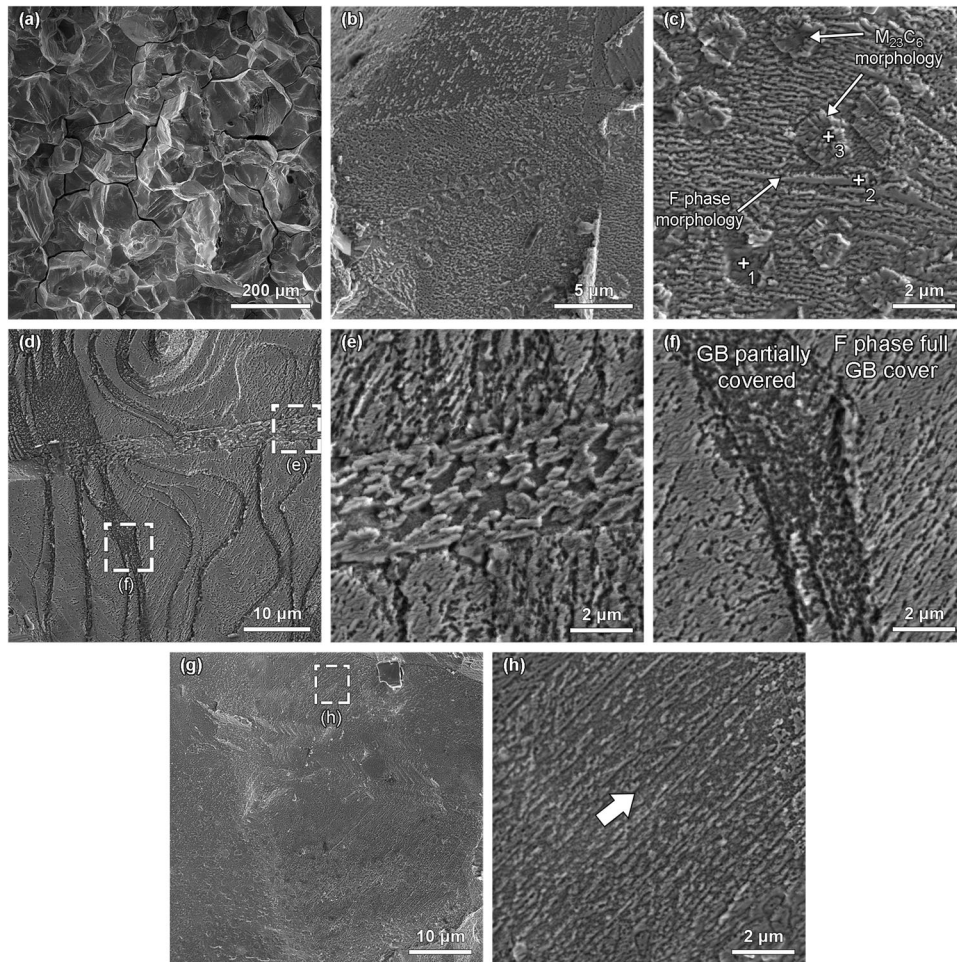
Figure 2 presents scanning electron microscope (SEM) images of the fracture surface of the failed seal. The fracture was fully intergranular with no evidence of plastic deformation (Fig. 2a). High-resolution images showed that the fracture surface was fully or partially covered by secondary phases (Fig. 2b–h). The characteristic morphologies of the two intergranular precipitates were identified, e.g., irregular and blocky for  $M_{23}C_6$  and continuous or discontinuous sheet for F phase (Fig. 2c, f, h)<sup>34</sup>. As a reference, the morphologies of intergranular precipitates in the bulk material are illustrated in Supplementary Fig. 1. In general, at each GB plane, the precipitates presented the same nature and morphology. Some grains, such as the one in Fig. 2d, were almost entirely covered by a continuous F phase network. Occasionally, parallel lines were observed on the fracture surface, linked to shadows produced by the thin precipitates (Fig. 2h).

The preserved morphology of the intergranular precipitates observed in the fracture surface by SEM and TEM suggested that the precipitates did not fracture during crack propagation. Therefore, the crack advanced by the interfacial decohesion

**Fig. 2 Fracture surface.** **a** Low magnification SEM images of fracture surface showing intergranular cleavage mode. **b–h** High-resolution SEM images showing intergranular precipitates covering the fracture surface. **c** Precipitates with the typical blocky and sheet-like morphologies of  $M_{23}C_6$  and F phase, respectively, as denoted in the image.

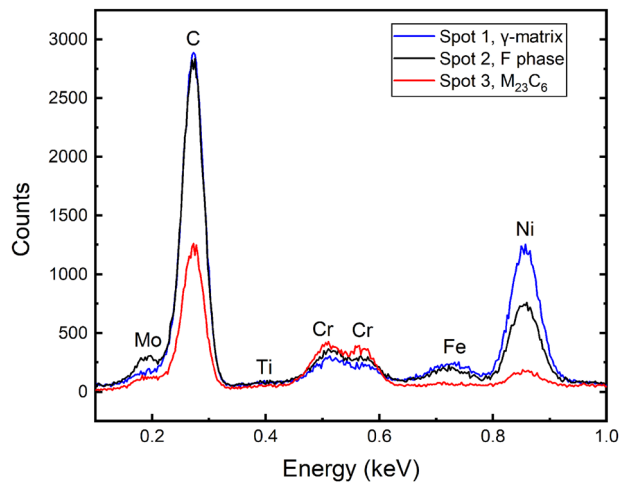
Low kV energy-dispersive X-ray spectroscopy (EDS) in Fig. 3 supported the presence and identity of the intergranular precipitates on the fracture surface. Low kV EDS spectra were

acquired at positions 1–3 of Fig. 2c, which corresponded to (1)  $\gamma$ -matrix area free of intergranular precipitates, (2) a sheet-like precipitate (F phase), and (3) a blocky precipitate ( $M_{23}C_6$ ). Both intergranular precipitates presented a higher Cr content than the matrix (more evident on the blocky precipitate) and a lower Ni content. Moreover, the F phase sheet had a higher Mo content than the matrix and the blocky  $M_{23}C_6$  precipitate. These results were consistent with earlier scanning transmission electron microscopy (STEM)-EDS characterization of the F phase and  $M_{23}C_6$ <sup>34</sup>. TEM analysis of the crack tip cross-sections, such as the one presented in Fig. 4, supported the attachment of intergranular precipitates to the crack surface. In the TEM foil, intergranular precipitates were observed on both sides of the crack (Fig. 4). These precipitates were identified as hexagonal F phase by analyzing selected area diffraction (SAD) patterns acquired at  $[11\bar{2}]_F$  and  $[10\bar{1}0]_F$  zone axis (Fig. 4b, c)<sup>34,41,42</sup>. F phase precipitates were semicoherent with the left  $\gamma$ -matrix grain and presented the typical morphology previously characterized in the bulk material, i.e., flat and rounded interfaces with the semi-coherent (left) and incoherent (right)  $\gamma$ -matrix grains, respectively<sup>34</sup>. Generally, discontinuous precipitates were found attached to both surfaces of the crack. In contrast, longer precipitates tended to remain attached to the incoherent  $\gamma$ -matrix grain, such as the 4  $\mu$ m long continuous precipitate in Fig. 4.

**Fig. 3 Low kV EDS on the fracture surface.** Point analyses were performed on the precipitates and matrix marked in Fig. 2c. Scan performed on a precipitate with F phase morphology was richer in Cr and Mo than the  $\gamma$ -matrix and presented less Ni. Likewise, the EDS spectrum collected on blocky precipitate was the richest on Cr and poorest on Ni, consistent with the  $M_{23}C_6$  composition. These EDS spectra are affected by both the chemical composition and the thickness of the precipitates. In this regard, given that F phase is typically 15 nm thick, the EDS scan would include a higher contribution of the sub-surface  $\gamma$ -matrix compared to the 100 nm thick  $M_{23}C_6$ . The carbon peaks should be disregarded as they result from unavoidable surface contamination. This EDS analysis correlates well with the one performed on Alloy 716 elsewhere<sup>28</sup>.

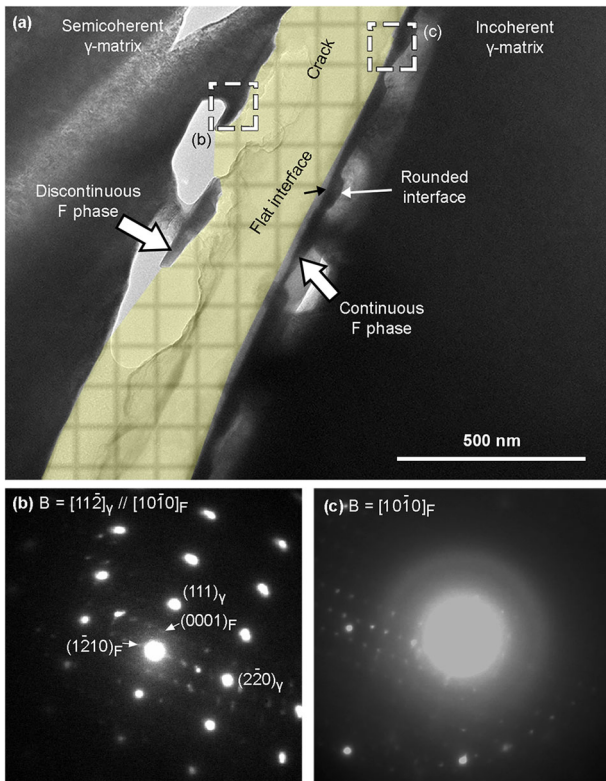
**Fig. 4 TEM crack tip cross-section.** **a** Bright field image, where the yellow area (NB: color added in post-processing to enhance the contrast) illustrates the crack path and the white arrows indicate F precipitates. The  $\gamma$ -matrix around the crack was partially milled out due to the difference in hardness between the  $\gamma$ -matrix and intergranular precipitates. This could not be avoided in the four samples extracted by FIB milling. Nonetheless, the intergranular precipitates were preserved and the crack propagation path was still evident (denoted in yellow in **(a)**). **b**, **c** SAD patterns obtained from the boxes marked on **(a)**, with the reflections of **(b)** F phase and the semicoherent  $\gamma$ -matrix on the left side of the crack and **(c)** F phase and the incoherent  $\gamma$ -matrix on the right side of the crack. None of the TEM specimens extracted along a crack from the failed seal presented  $M_{23}C_6$  carbide.

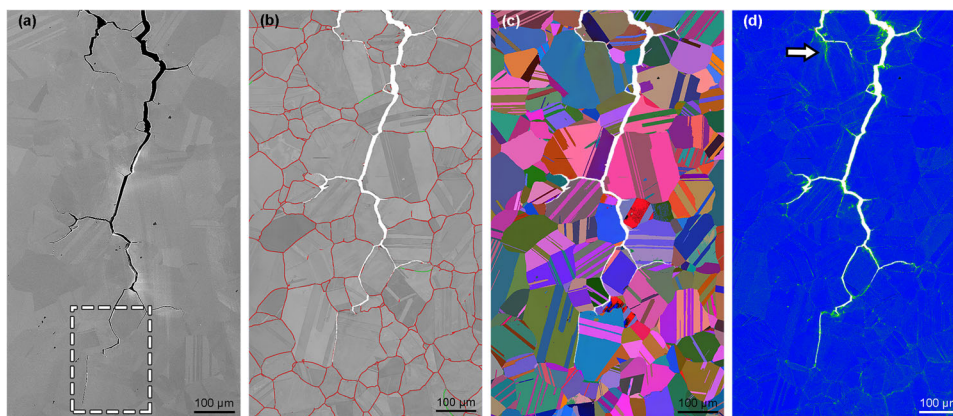
Consistently with the fracture surface, the crack propagated intergranular and along high-angle GBs, which were predominant compared to low-angle GBs (Fig. 5b, c). According to the kernel average misorientation (KAM) map, there was not predominant  $\gamma$ -matrix misorientation near the crack; thus, the crack opened with almost no deformation of the  $\gamma$ -grains (Fig. 5d). Nonetheless, local plastic deformation was found following CTBs adjacent to the main crack (indicated by the arrow in Fig. 5d) and at crack arresting or inflexion points. In most cases, crack arrested or presented a discontinuous propagation at triple junctions or general GBs and CTB intersections.

**Fig. 5 Crack cross-section analysis in the as-polished condition.** **a** SEM image. **b–d** EBSD maps with the crack shape overlapped in white. **b** Band contrast map with high and low angle regular GBs in red and green, respectively. **c** All Euler-angle map. **d** KAM map.

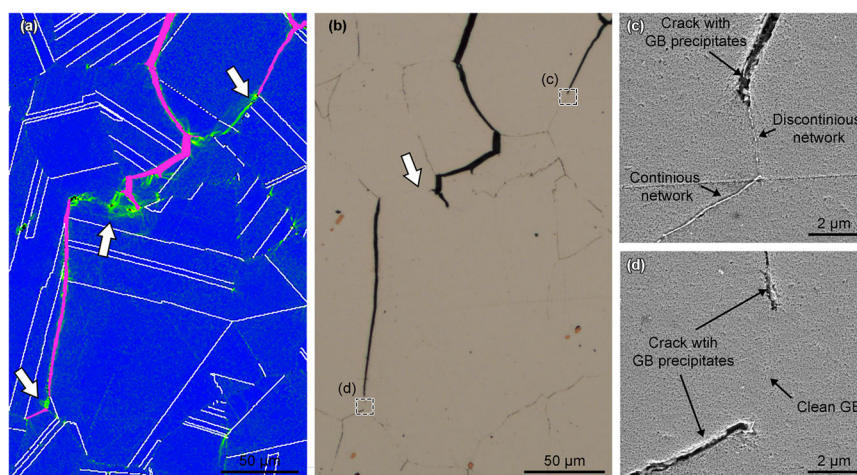
Figure 6 compares the EBSD KAM map and the distribution of intergranular phases around the crack-tip shown in Fig. 5a. The KAM map in Fig. 6a has the crack shape superimposed in pink and the CTBs in white. Matrix deformation was observed when the crack propagation was discontinuous or when the crack arrested, as indicated by the arrows in Fig. 6a. Interestingly, according to the micrographs after etching, those deformation areas coincided with clean GB or, less commonly, a discontinuous network of intergranular precipitates (Fig. 6c, d, respectively). We corroborated that the discontinuous precipitation network in Fig. 6c was of discontinuous F phase by the TEM analysis of a foil extracted across the GB, shown in Supplementary Fig. 2. Additionally, SEM images showed intergranular precipitates within the crack (Fig. 6c, d). Finally, intergranular precipitates did not form at CTBs, as illustrated by comparing Fig. 6a, b.

**Fig. 6 EBSD and intergranular precipitates occurrence analysis of crack tip.** Figure 6 analysis location is indicated in Fig. 5a. **a** KAM map indicating misorientation within the grains of the as-polished crack cross-section. **b** Optical micrographs and **c, d** SEM images of the occurrence of intergranular precipitates after chemical etching. Arrows and boxes indicate discontinuous propagation of the crack, which corresponded to clean or partially covered GBs and  $\gamma$ -matrix deformation.

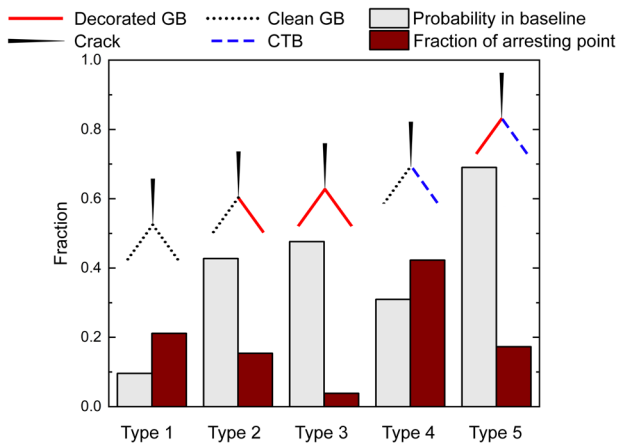
Figure 7 and Supplementary Table 1 summarize the statistical analysis of the crack arresting points. The crack arresting points were classified based on the presence of the intergranular phases (according to the optical micrographs) and the nature of the surrounding GBs, i.e., if the crack was connected to regular GBs or CTBs. Five types of arresting points were identified, as indicated in Fig. 7 and Supplementary Note. The count of each type was divided by the total of arresting points studied to calculate the fraction of each arresting point type. The probability of finding that type of junction in the baseline material was estimated according to Supplementary Note. The measured fraction of each type of arresting point and its probability to find the respective configuration of GBs in the base material are plotted in Fig. 7. Results showed that cracks arrested generally around clean GBs (Type 1 and 4). However, these types of junctions occurred less frequently in the baseline material microstructure. In contrast, the arresting points with adjacent intergranular precipitates (Type 3, 4, and 5) were uncommon, despite being more abundant in the base material. Therefore, results indicated that the decorated GBs offered low crack propagation resistance. The statistical significance of the detrimental effect of the decorated GBs was supported by  $P$ -values lower than  $2.5 \times 10^{-5}$  (Supplementary Note and Supplementary Table 1).

**Fig. 7 Statistical analysis of main crack arresting points.** The column chart shows, for each crack arresting point type, the measured fraction (red) along with the probability of that type GB junction in the baseline material (gray). The arresting points were classified based on the adjacent GBs' nature and decoration. Five categories were defined, depending on whether the crack tip was adjacent to (Type 1) two clean regular GBs, (Type 2) a clean and a decorated regular GBs, (Type 3) two decorated regular GBs, (Type 4) a clean regular GB and a CTB, and (Type 5) a decorated regular GB and a CTB.

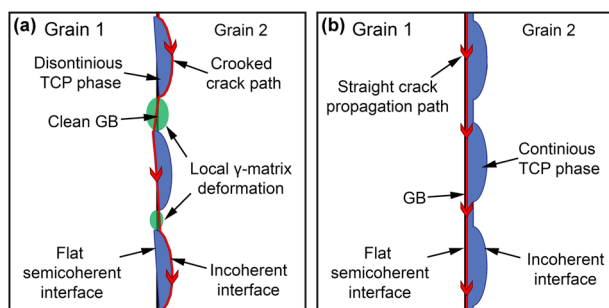
different F phase morphologies, illustrated in Fig. 8. For the discontinuous F phase precipitates, the crack path would be tortuous since it would be required to change direction to cross at least one of the interfaces of the adjacent grains (Fig. 8a). Additionally, considering the EBSD results shown in Fig. 6, clean GBs between the precipitates would locally deform before cracking, increasing the required energy for crack advance. Based on their morphology, crack growth around the blocky  $M_{23}C_6$  precipitates would be similar to that around the discontinuous F phase. However, the larger spacing between  $M_{23}C_6$  particles compared to the discontinuous F phase precipitates would result in higher strains (Supplementary Fig. 1a, b)<sup>34</sup>.

On the contrary, straight crack propagation can occur at the flat interface between the continuous F phase precipitate and the  $\gamma$ -matrix (Fig. 8b). Since the final crack path is shorter and results in no local matrix deformation, cracking around continuous precipitates would require less energy than around discontinuous ones. Furthermore, free crack paths favored by the continuous F phase precipitates would be in the  $\mu\text{m}$  range, as these precipitates were found to be as long as 45  $\mu\text{m}$  in the baseline material<sup>34</sup>.

**Fig. 8 Proposed crack propagation pathway.** Cracking around (a) discontinuous and (b) continuous intergranular F phase precipitates.
